Maule Aircraft Corporation

Service Letter #18.
Models Effected M4-220C and M-4-220S
Mandatory on Serial NO's 2001c thru 2025c, 2001S

SERVICE LETTER #18

THROTTLE CONTROL

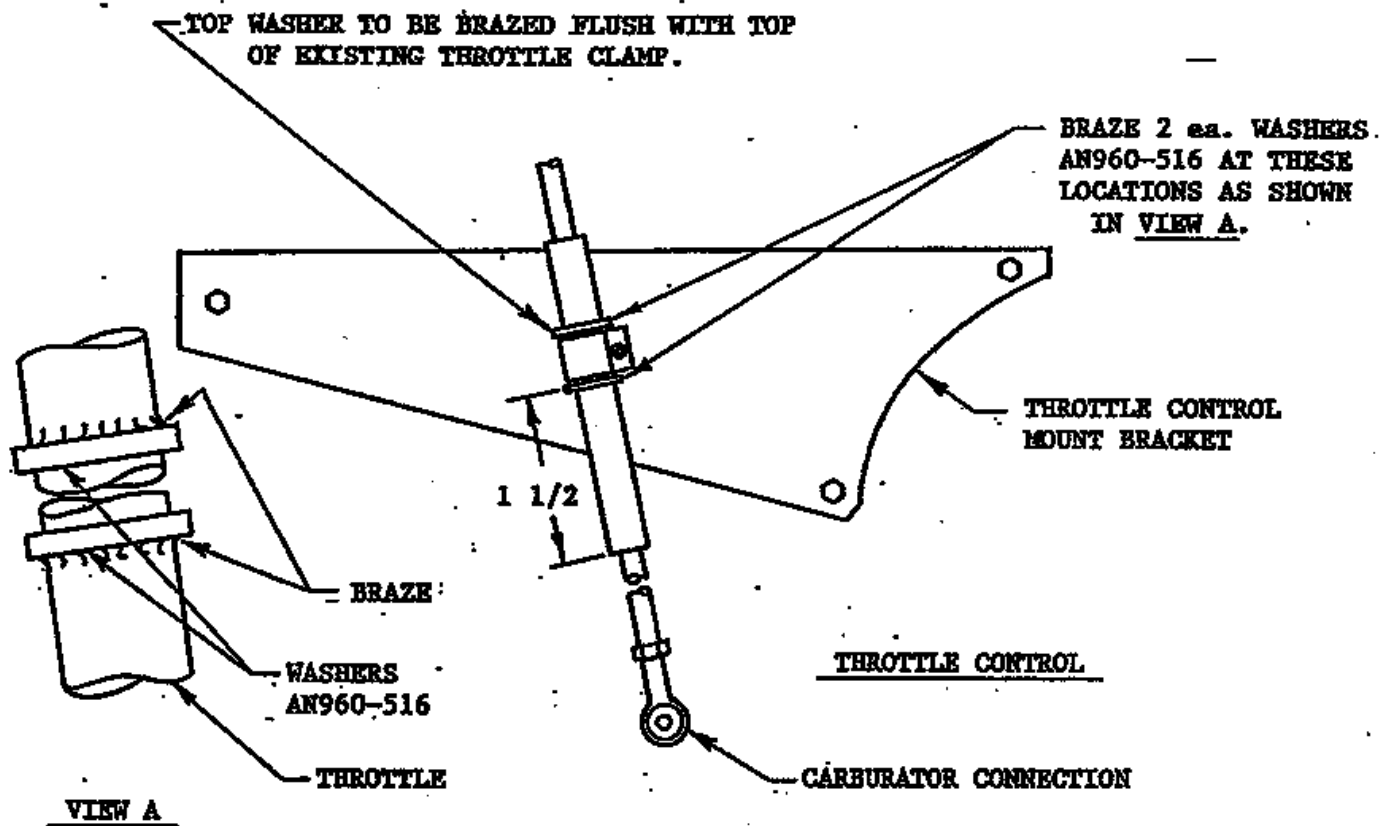
We have discovered a possible malfunction of the throttle linkage attachment.

CAUTION: DO NOT OVERHEAT WHEN BRAZING WASHERS.

NOTE: LUBE SHAFT WITH LIGHT WEIGHT ENGINE OIL AFTER BRAZING.

2 ea. AN960-516 WASHERS
