Maule Aircraft Corporation

Service Letter # 8

Models effected Bee Dee M-4, M-4 & M-4-210

INSTRUCTION SHEET

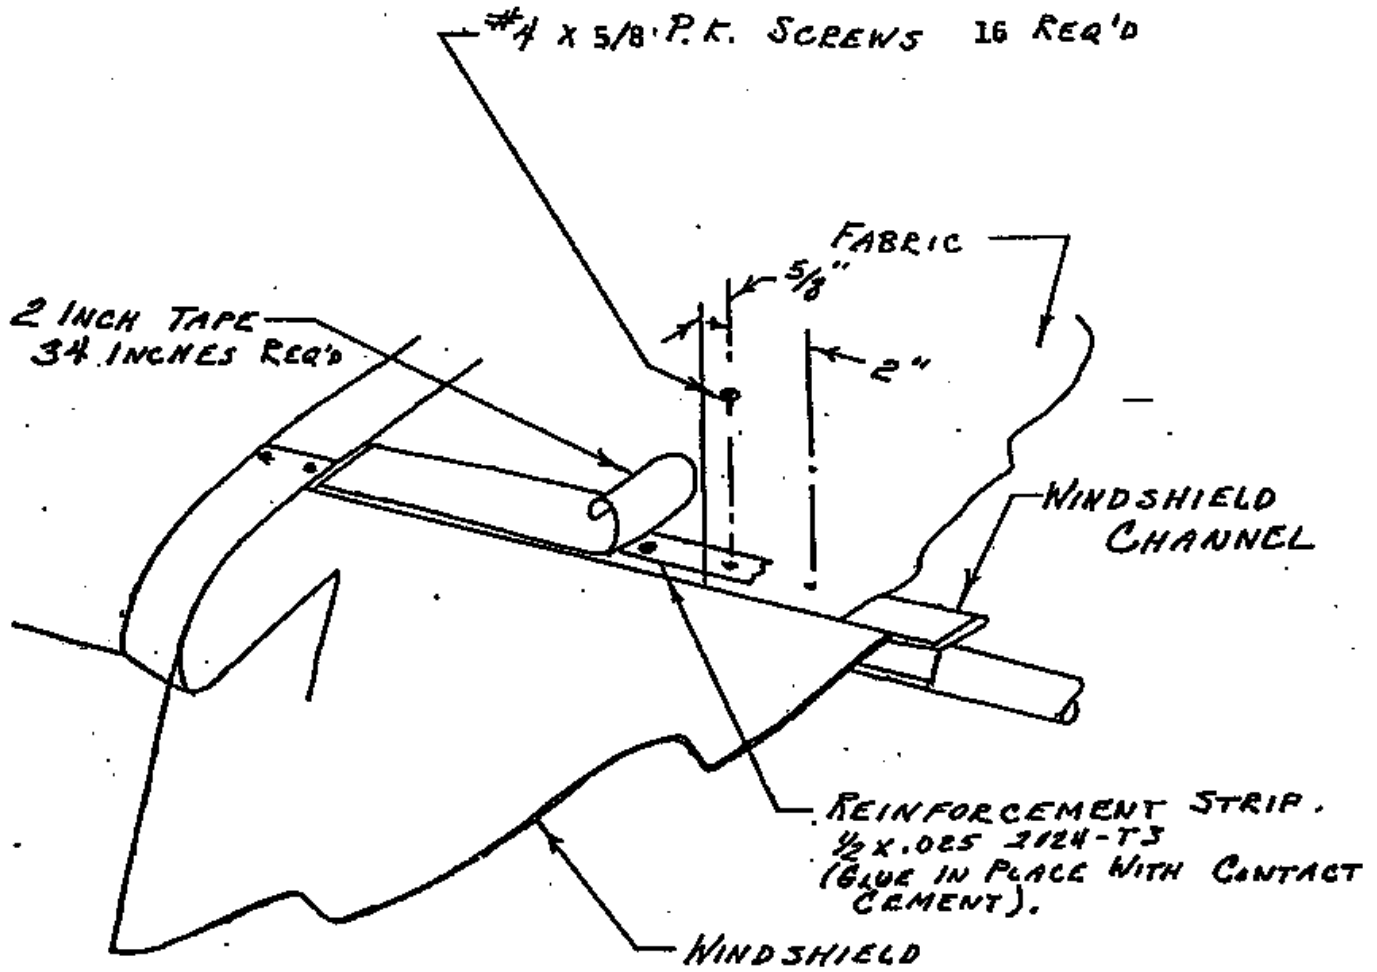
The fabric covering has come loose at the windshield on one of our aircraft and the FAA is going to put out a Airworthiness Directive on our aircraft to prevent additional failure of this type.

1. Drill 16 holes using #44 drill (.086) holes at two (2) inch spacing spanwise along windshield channel as shown in figure 1, drill through new reinforcement strip, fabric, windshield channel (both upper and lower flanges) and windshield. Center holes in reinforcement strip.

4. Use contact cement to glue reinforcing strip to fabric.
5. Install number 4 x 5/8 P. K. screws as shown in figure 1. Install screws in snug without over tightening.
